# Manhole Inspection Summary

Manhole # S21MM\_023MH

Insp Date: **7/2/07 7:27 AM**

**Location** Address: **2212 WINDSOR AVE**

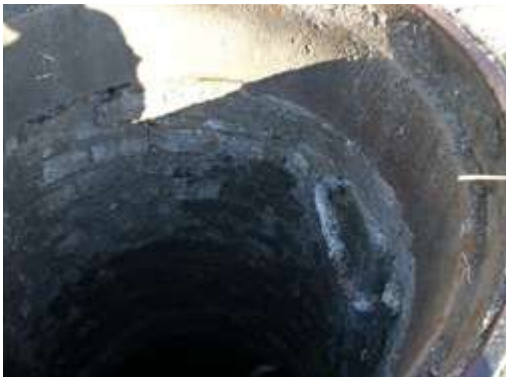
Defect 3

Infiltration: ☒ None ☐ Joint ☐ Cracks ☐ Mortar ☐ Roots ☐ Wall

INFILTRATION OF CORBEL

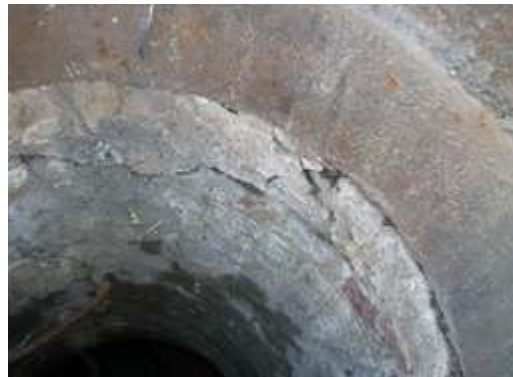
Defect 2

Condition: ☐ Sound ☒ **Cracked** ☐ Root Intrusion ☐ Loose Brick ☒ **Deteriorated**

CRACKED AND DETERIORATION OF CORBEL

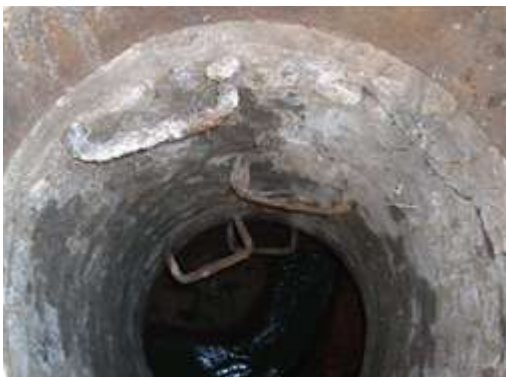
Defect 1

**Steps** Count: **6** Missing: **0** ☒ **Corroded**

CORRODED STEPS

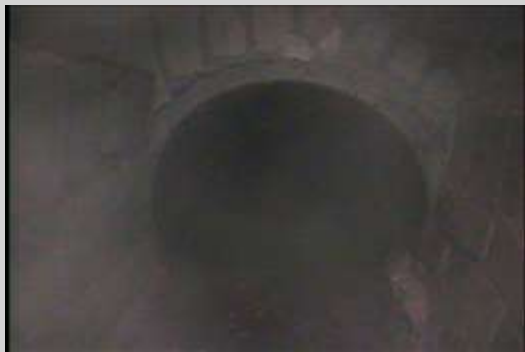
12 O'Clock Outflow

15 in. Circular Gravity Sewer  
Pipe Out @ 12 O'Clock

Pipe Height: **15.6** (in.) Rod and Bar (Angled)  
Pipe Material: **Clay** ☐ Pipe Lined  
Invert Depth: **10.20** (ft.) Flow Characteristics: **Fast**  
Deposits: ☒ None ☐ Mud ☐ Sludge ☐ Debris ☐ Grease  
Silt Depth: (in.) Deposits Extent:  
Infiltration: **None** Pipe Seal Cond: **Sound**

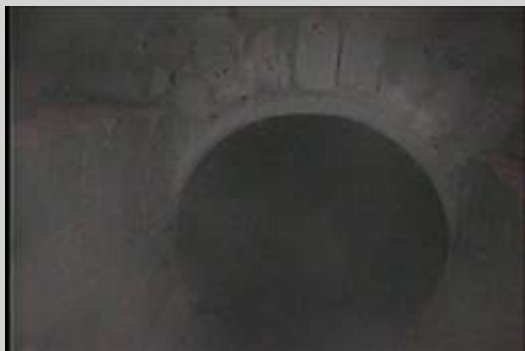
9 O'Clock Inflow

15 in. Circular Gravity Sewer  
Pipe In @ 9 O'Clock

Pipe Height: **15.6** (in.) Rod and Bar (Angled)  
Pipe Material: **Clay** ☐ Pipe Lined  
Invert Depth: **10.11** (ft.) Flow Characteristics: **Fast**  
Deposits: ☒ None ☐ Mud ☐ Sludge ☐ Debris ☐ Grease  
Silt Depth: (in.) Deposits Extent:  
Infiltration: **None** Pipe Seal Cond: **Sound**
